Title: Multi-Site Fatigue Testing and Characterization of Fuselage Panels from Aging Aircraft Structure

Multi-Site Fatigue Testing and Characterization of Fuselage Panels from Aging Aircraft Structure

Sandeep R. Shah¹, Todd B. St John¹, Ian L. Pryce, Jr.¹,
Gregory A. Shoales² and James M. Greer, Jr.²

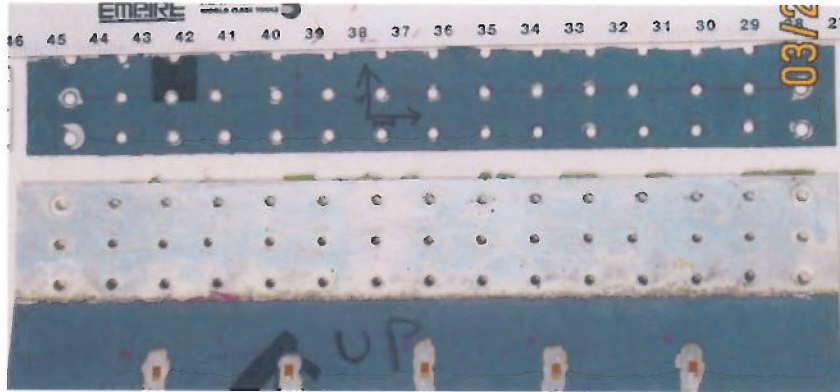
The panels were carefully investigated after failure to identify the locations of fatigue damage and to determine where panels failed under overload due to accumulated damage leading to fast fracture. It was easy to identify these features optically, as the fatigue regions showed planar fracture surfaces oriented predominantly perpendicular to the loading axis, while the fast fracture region was characterized by dominant shear lips. Figure 6 shows a panel immediately after failure. It can be seen that the top panel of the lap joint has failed at the topmost

row of the fasteners, while the bottom panel has remained intact. The unsymmetric lap joint creates an out-of-plane load eccentricity such that the topmost row of the fasteners experiences the maximum flexural tensile load due to tension loading. This additional load makes the topmost row of fasteners more susceptible to failure. For most panels, failure occurred at this location. Some panels, however, had spot welded doublers in the lap joint, creating dual laps in one lap joint. Such panels primarily failed by the failure of the topmost row of the spot welded doubler. Again the topmost row of the spot welds experiences higher stress due to the eccentric loading and is therefore the first to fail.

Figure 6: Failure of the test panel at the top most row of the fasteners (nearest the scale; scale in inches). It can be seen that the bottom panel is completely intact.

Table 1 lists the size of the cracks emanating from each fastener hole along the failed fastener row, shown in Figure 6, in which the 15 holes are numbered from left to right ("1" being the left-most hole). Cracks emanating from the left side of the hole are simply labelled with the hole number. Cracks emanating from the right side of the hole are labelled with a "b" suffix (e.g., 14b). The crack lengths are represented in a and c dimensions, where a is the length of the crack along the face of the skin and c is the length of the crack in the thickness direction of the panel. Where c is marked as t , it indicates that the crack has grown through the thickness of the panel. As seen from this table, fastener holes 1 and 15 showed no sign of fatigue cracking. They are the outermost rivets and, as mentioned earlier, these rivets were replaced with the next oversize rivet and were assembled with some interference specifically to avoid the crack initiation at these locations arising from edge effects. Video indicated the crack originated between fastener numbers 13 and 14. Analysis indicates the crack started from the left side of Hole 14. A few of the cracks from this panel with their identifying crack numbers are shown in Figure 7.

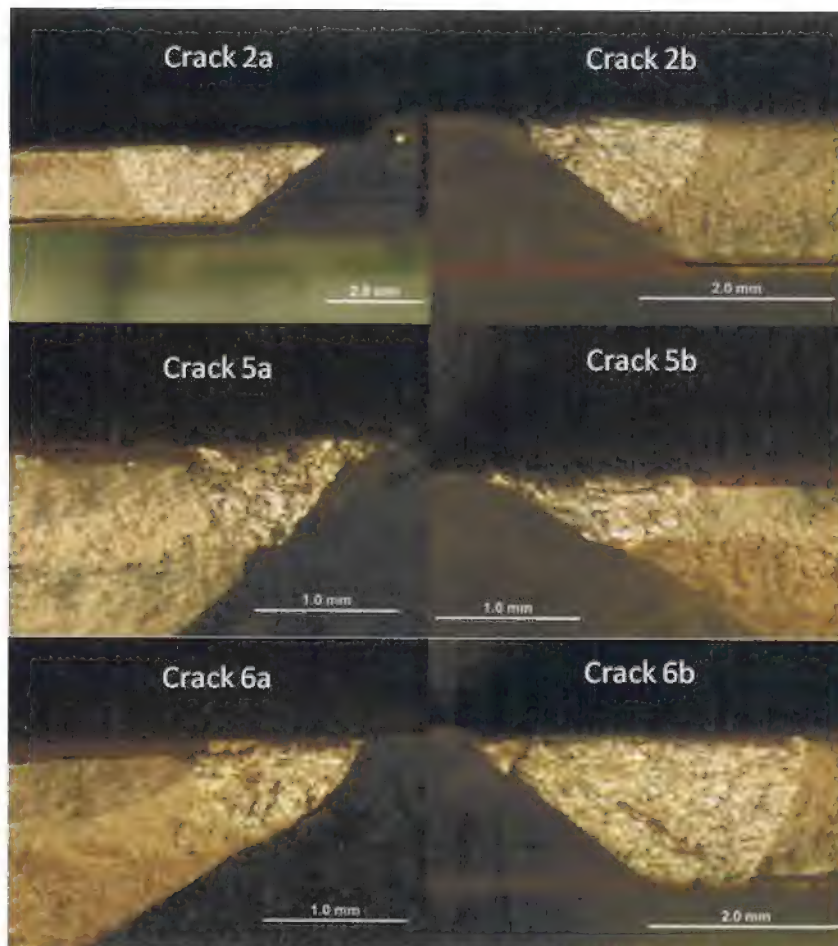
Figure 7 shows the cracks emanating from fastener holes 2, 5 and 6 of the failed panel shown in Figure 6. It can be seen that this panel had multi-site damage prior to its final failure. Close examination of Figure 7 reveals that all the cracks initiated from the knife edge of the countersink hole. This knife edge, due to its sharpness, has a higher stress intensity factor. Note also that the bottom of the countersink is in close proximity to the bottom panel of the lap joint. The actual initiation site could be due to fretting with the bottom panel, but detailed microstructural examination is beyond the scope of the present work. Data have been compiled for 14 panels in similar fashion. Furthermore, we have also created SolidWorks models for each panel showing the location and the extent of each crack. Figure 8 shows the SolidWorks model where the cracks are superimposed at the fastener hole locations.

Figure 7: Stereomicrographs of the cracks emanating from fastener holes 2, 5 and 6. The shiny surfaces are the fatigue cracks and the dull surfaces are the fast fracture regions.

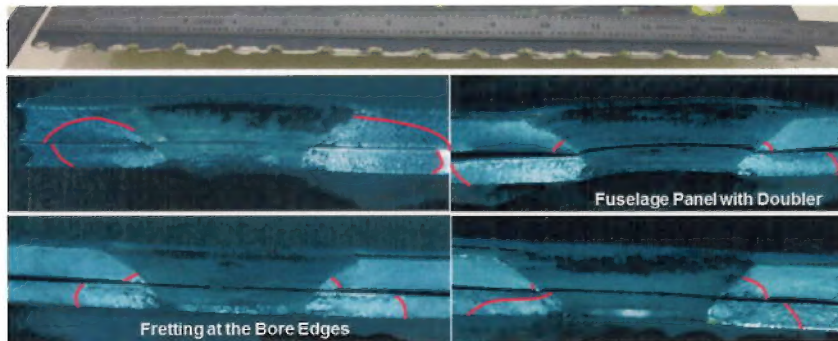
In some instances, doublers were found to have been used in the lap joint configuration. In such cases, the failure occurs in both panels and crack lengths are different from those seen in the welded panels. Figure 9 shows the failure of the panel which had a spot-welded doubler on the top panel. While the failure occurred at the fastener row of the lap joint, it can be seen that the crack propagates quite differently in both panels. The crack does not initiate from a common point of two panels, even though fretting is observed there. The cracks in this case are emanating from the bottoms of both of the panel skins. The bottom edge has a knife edge due to the countersinking operation. These knife edges are the initiation sites for both of the panel skins. Also, the lengths to which the cracks grow are different for the two panels. This is truly a case of multi-site damage (MSD) and multi-element damage (MED) which, when taken together, constitute wide-spread fatigue damage (WFD). It can be seen that this change in configuration has taken the simple case of MSD in one row of fasteners (previous case) to a much more complex one having the effects of inter-panel fretting and differential knife edges from a single countersinking operation. The fretting also indicates the presence of burrs from the countersinking operation. The panels were first spot welded and then machined to create the countersink for the fasteners. This machining operation appears to have left burrs and allowed some chips to become lodged between the two panels, leading to fretting. Modelling details all of these scenarios would be a very daunting task. The aim of the present work is therefore to create the database of panel failures and their crack locations and dimensions. The data are compiled in a similar manner as described above for all 14 test panels and are available to use for any kind of modelling. Detailed knowledge of the stress spectrum would also be required.

Figure 9: Failure of fuselage panels with spot welded doublers. It can be seen that the damage progresses in the two panels quite differently. In both panels the crack initiates from the bottom, where the countersink forms a knife edge.
